DETAILS OF DAMAGE TO INFRASTRUCTURE
OF TPSODL DURING THE CYCLONE 'GULAB'
ON 26TH SEPTEMBER 2021

Photographs of Damages of Infrastructure of TPSODL

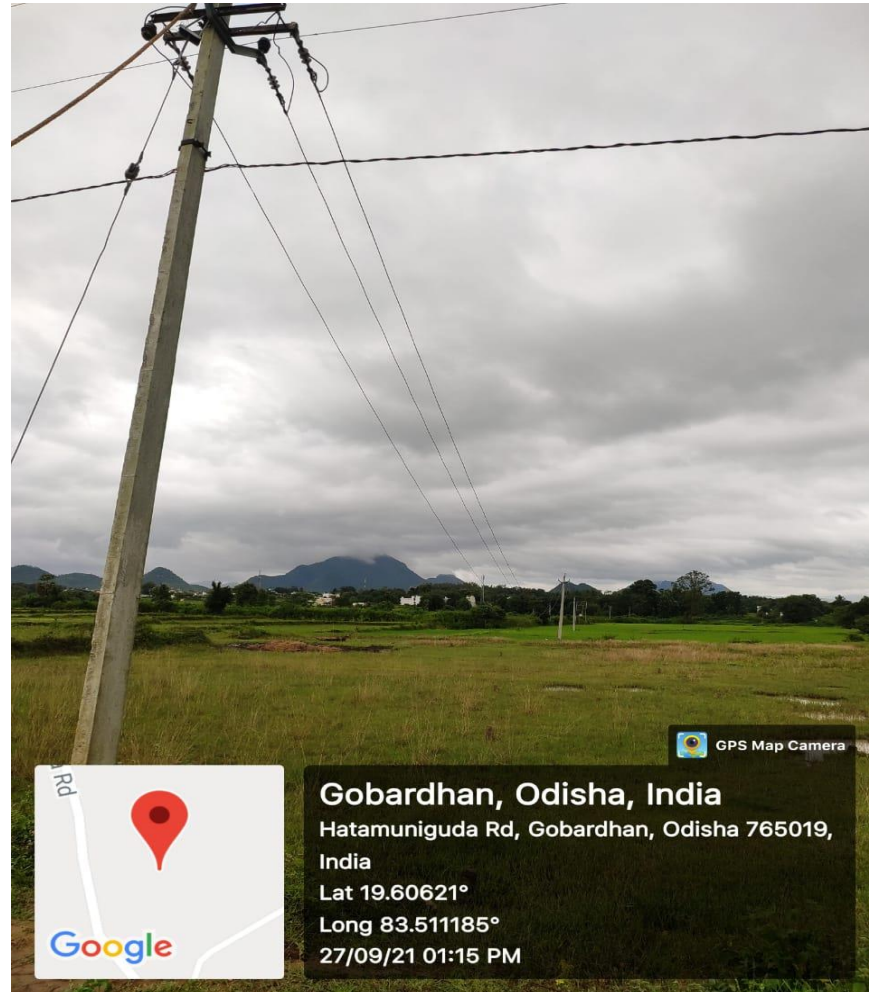
BEFORE(TILTED POLE)

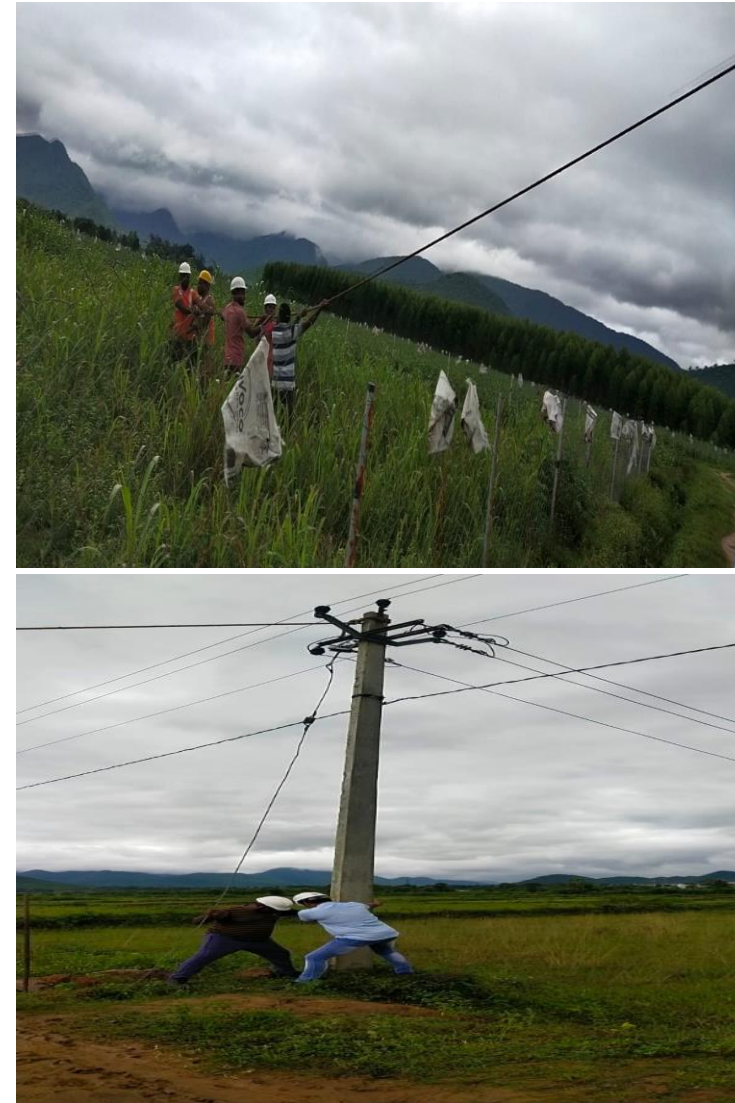
AFTER

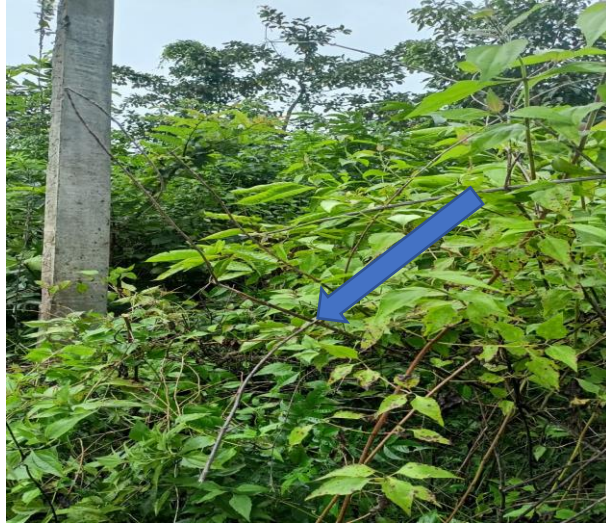
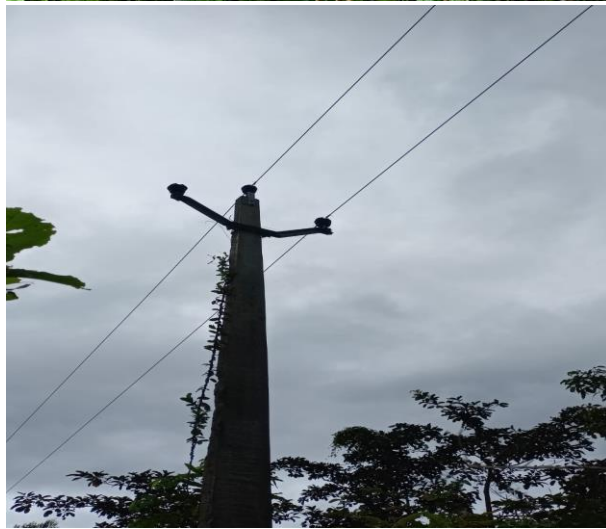
BEFORE

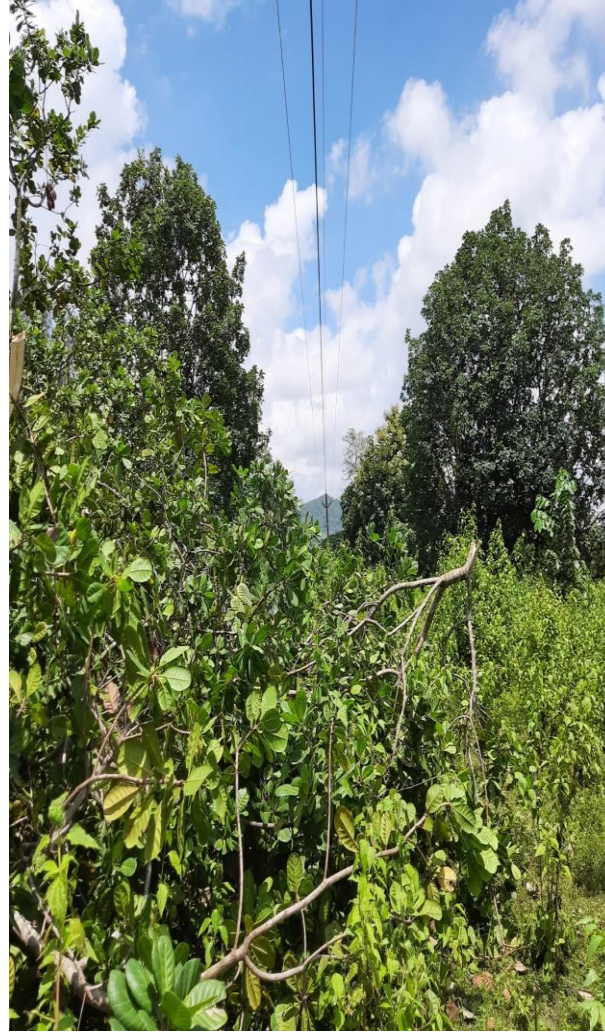
AFTER
RESTRINGING

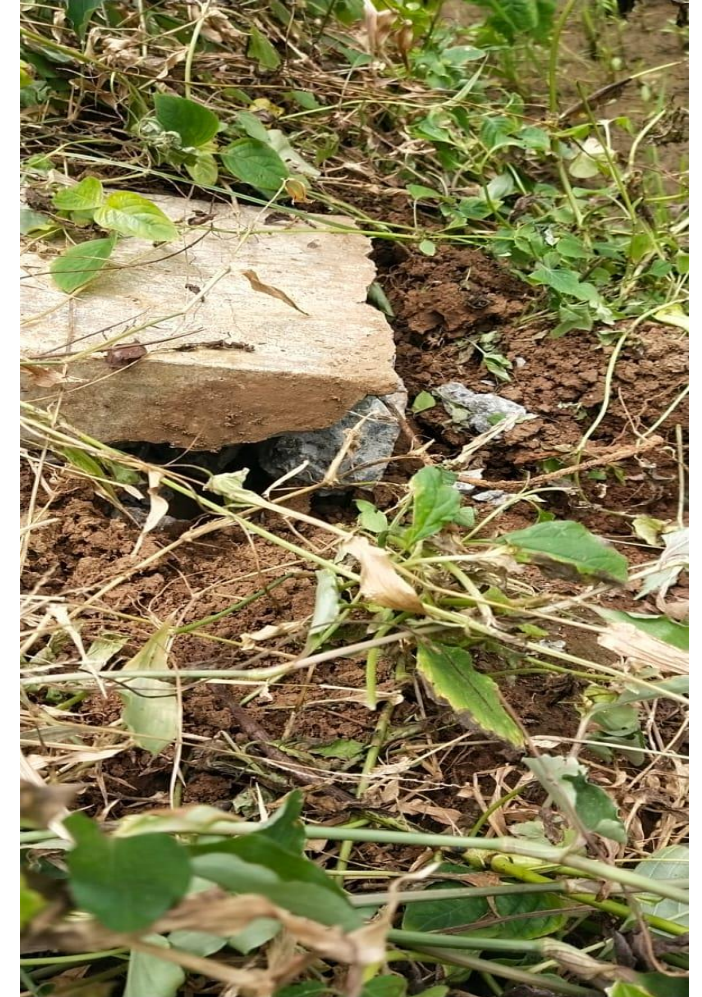
POLE BROKEN AT HANUMANTHPUR

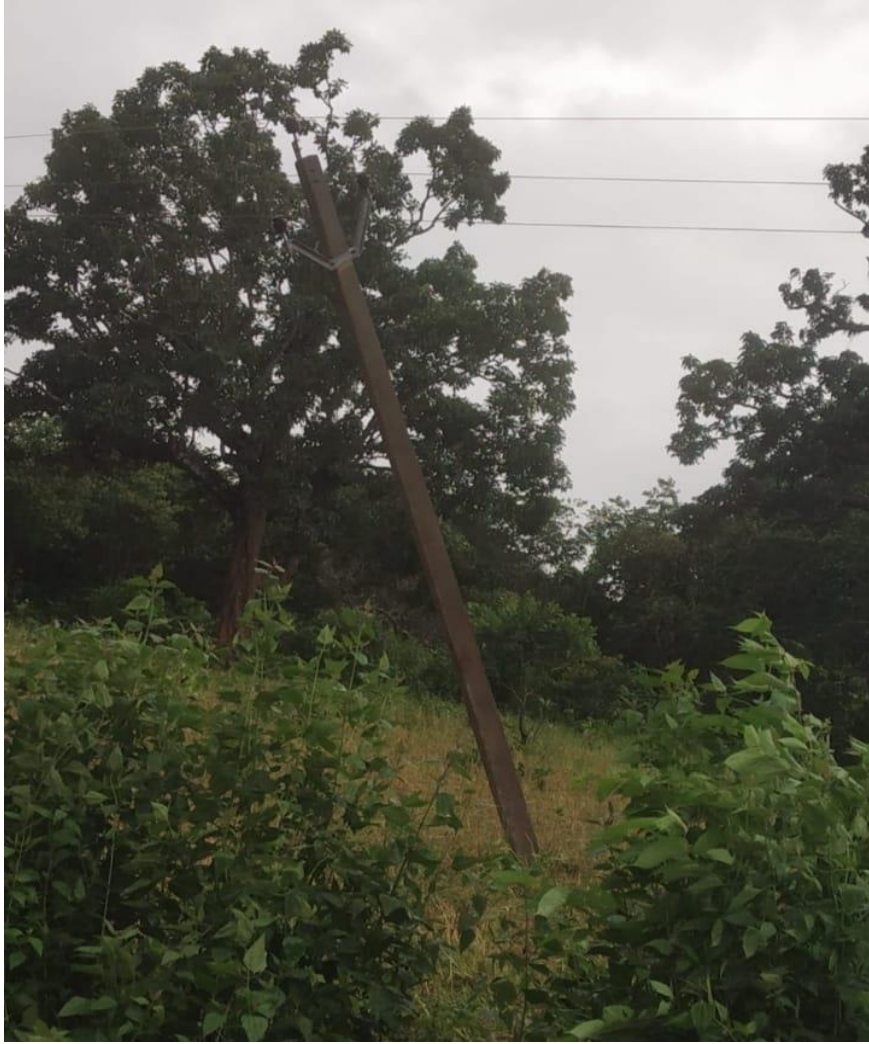
BEFORE

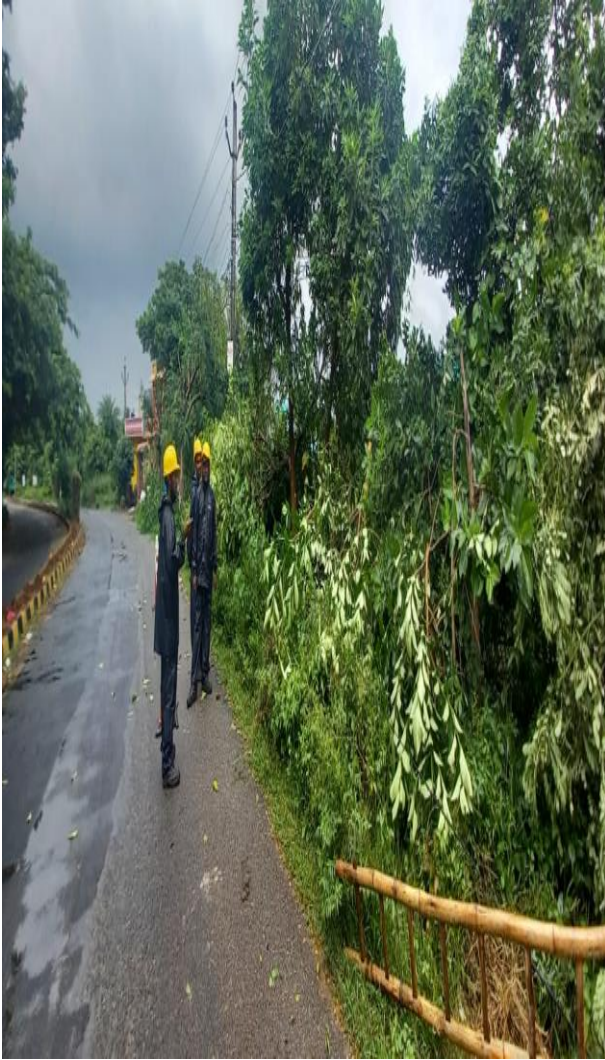
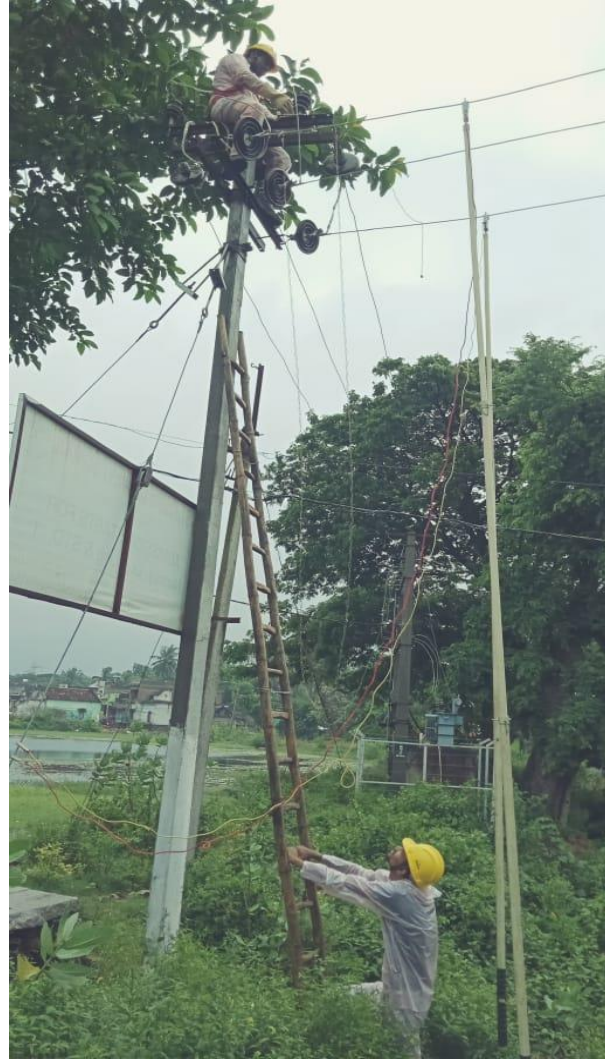
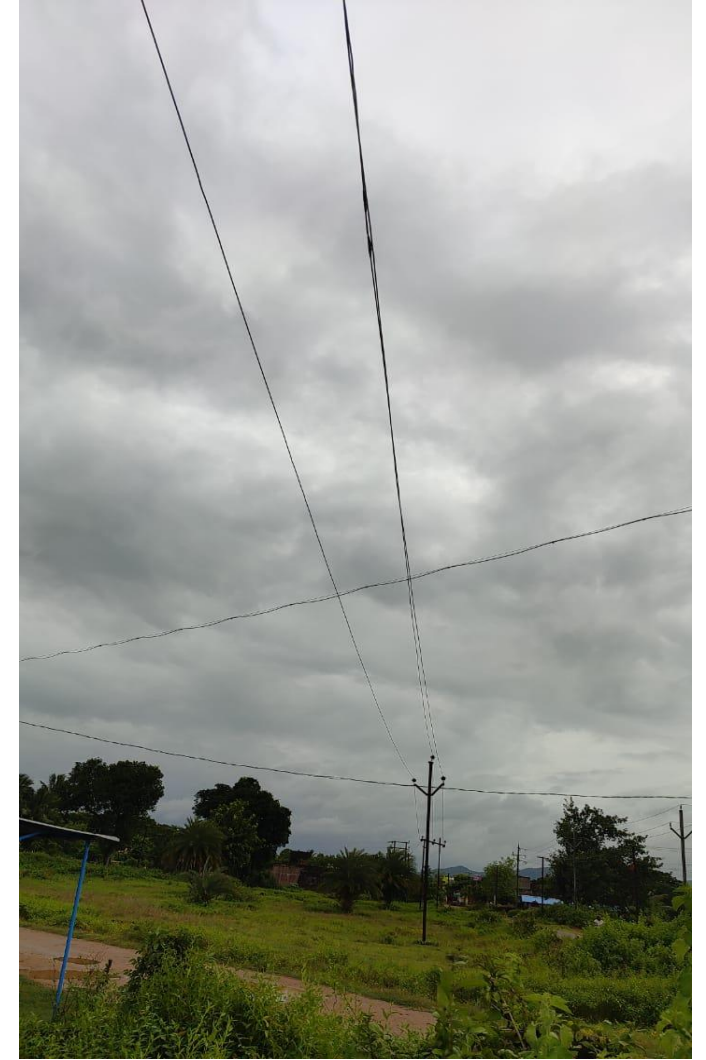
Twisted Conductor of 33KV Budhamba Feeder
